TRANSPORTATION RESEARCH CENTER

**Indiana University
Bloomington, Indiana 47403-1599**

ON-SITE AIR BAG INVESTIGATION

**CASE NO. - 96-16
FLEET - PRIVATE VEHICLE
LOCATION -
ACCIDENT DATE -**

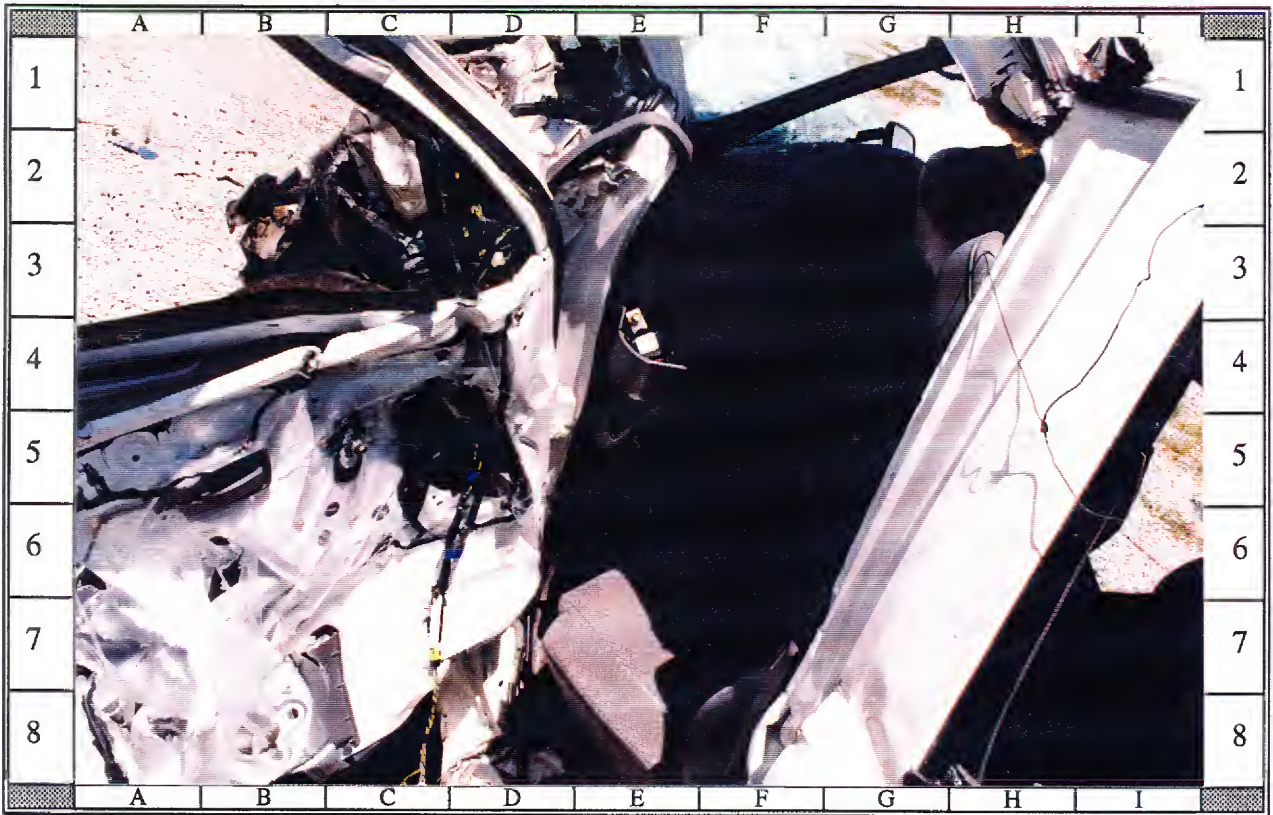
47: Residue of interior surface of Case Vehicle's driver door and front seating area;
NOTE: leftward displacement of driver's seat

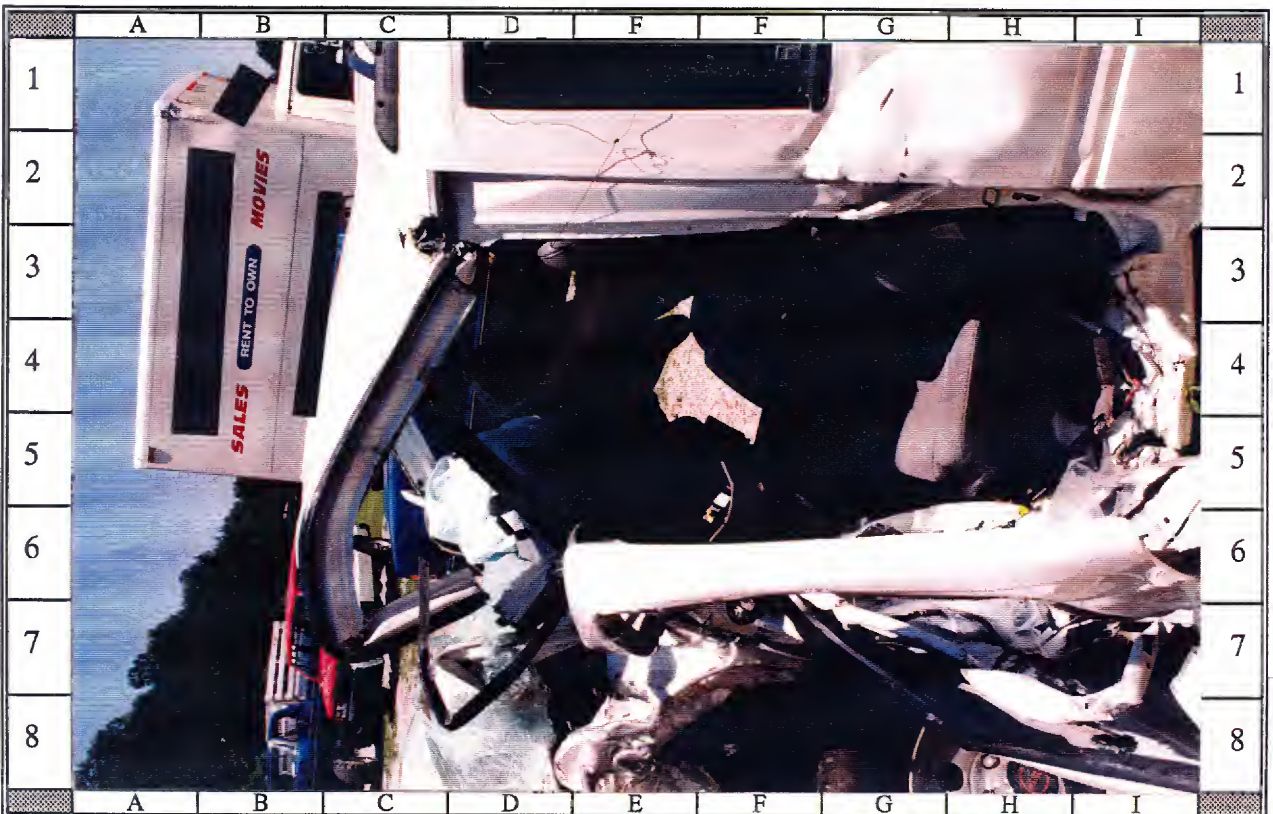
48: Case Vehicle's front seating area viewed from outside driver's door; NOTE:
deformed left "A"-pillar and unused male end of safety belt (cells F3--G3)

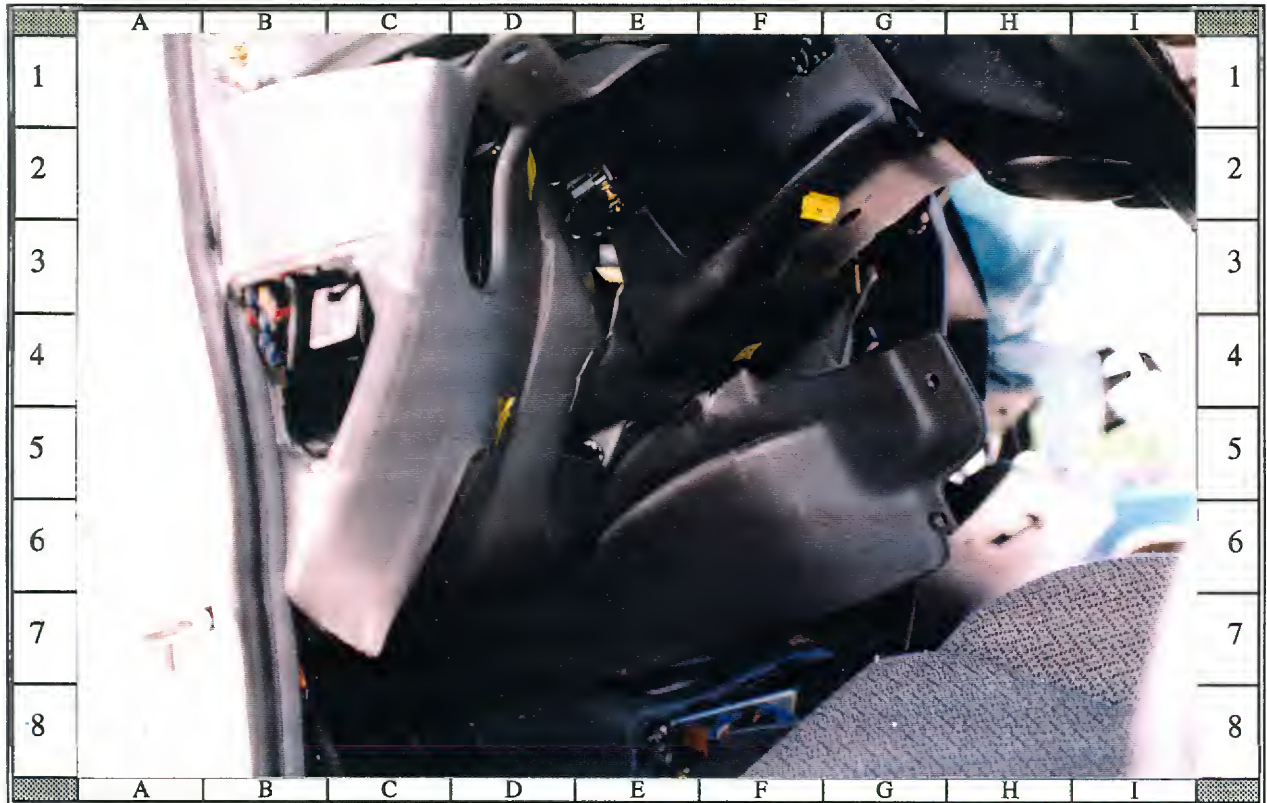
49: Close-up of Case Vehicle's left lower dash showing dash's rearward displacement and probable occupant contact points to lower dash and steering column

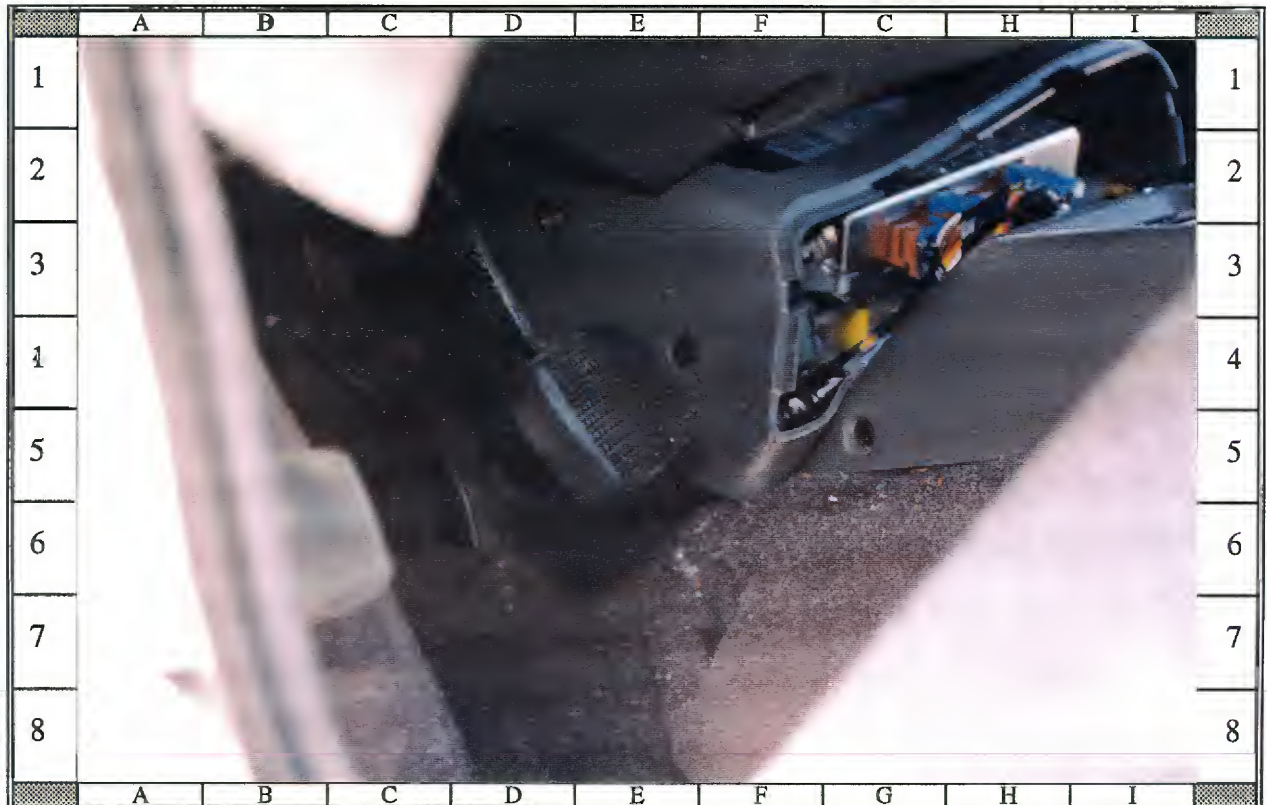
50: Close-up of Case Vehicle's lower center dash showing foot pattern on brake pedal; NOTE: rearward displacement of, and deformation to, the radio

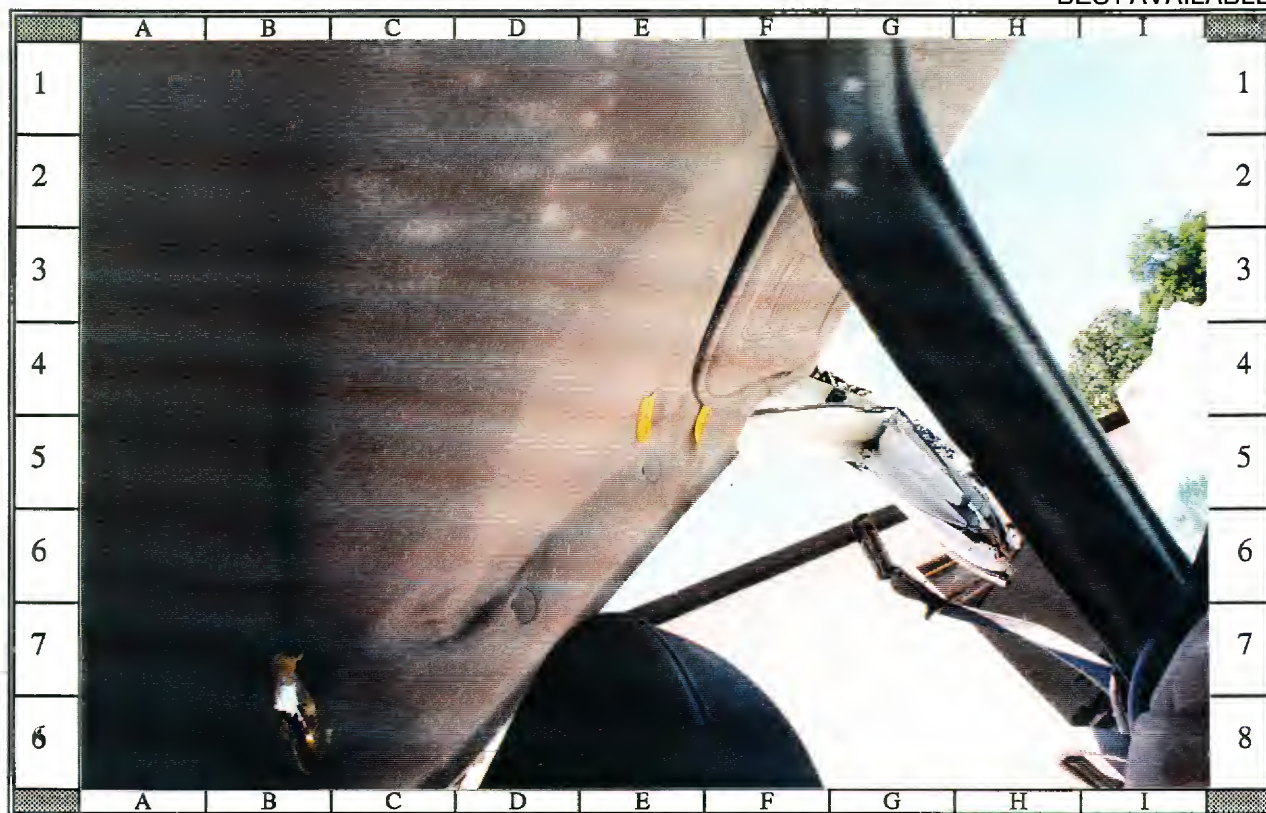
51: Case Vehicle's left upper "A"-pillar, roof header, and roof side rail; NOTE: roof hole (cells B7--B8) caused by bending roof rearward after "A"-pillars were cut

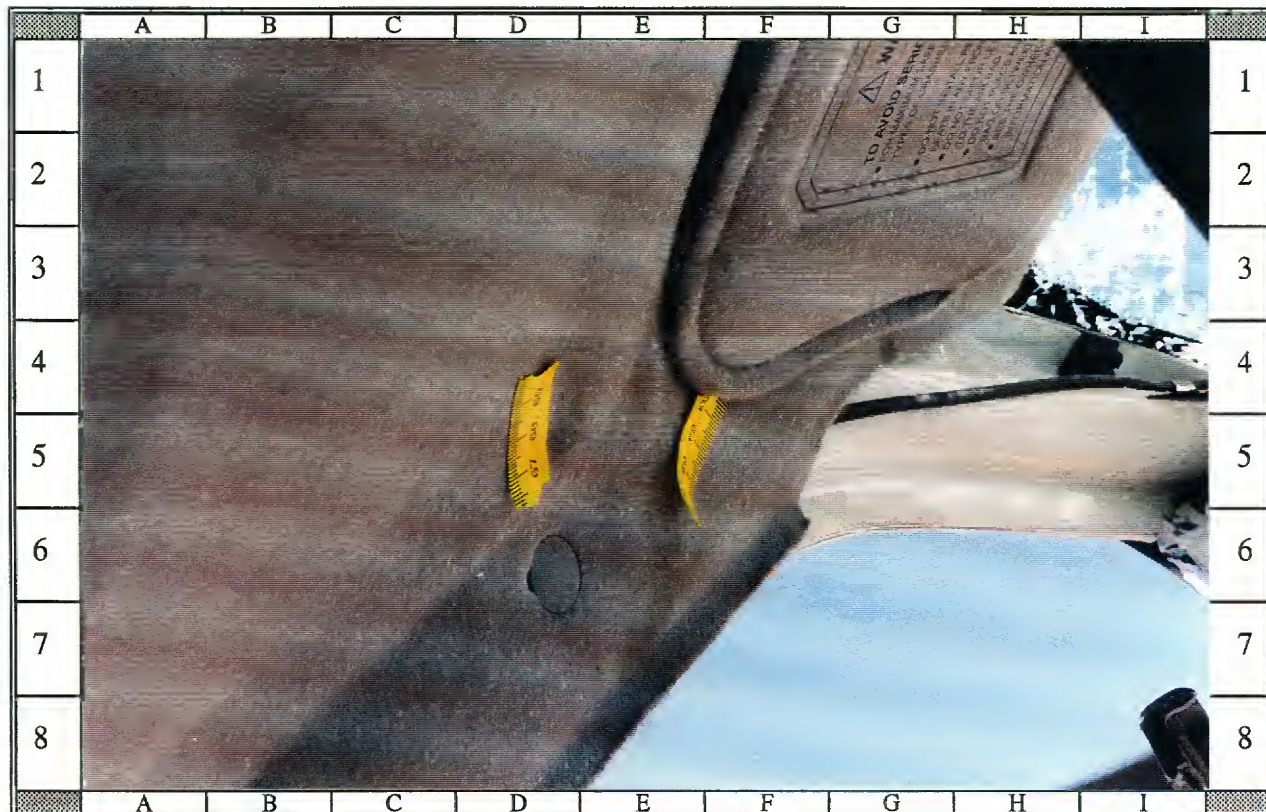
52: Close-up of Case Vehicle's left front roof corner and left sunvisor showing probable occupant contact points

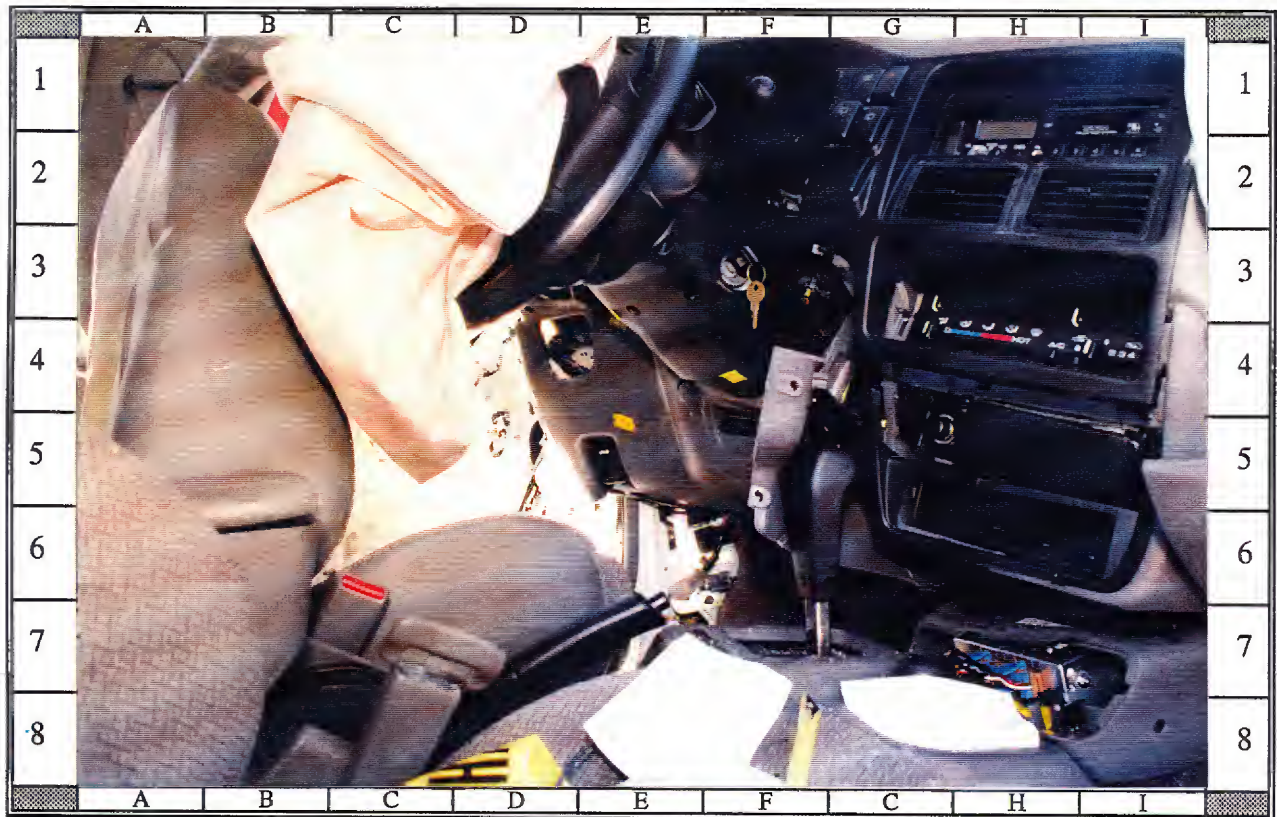
53: Close-up of Case Vehicle's lower left and center dash showing intrusion, deployed driver's air bag, and right front passenger's seat belt latch assembly

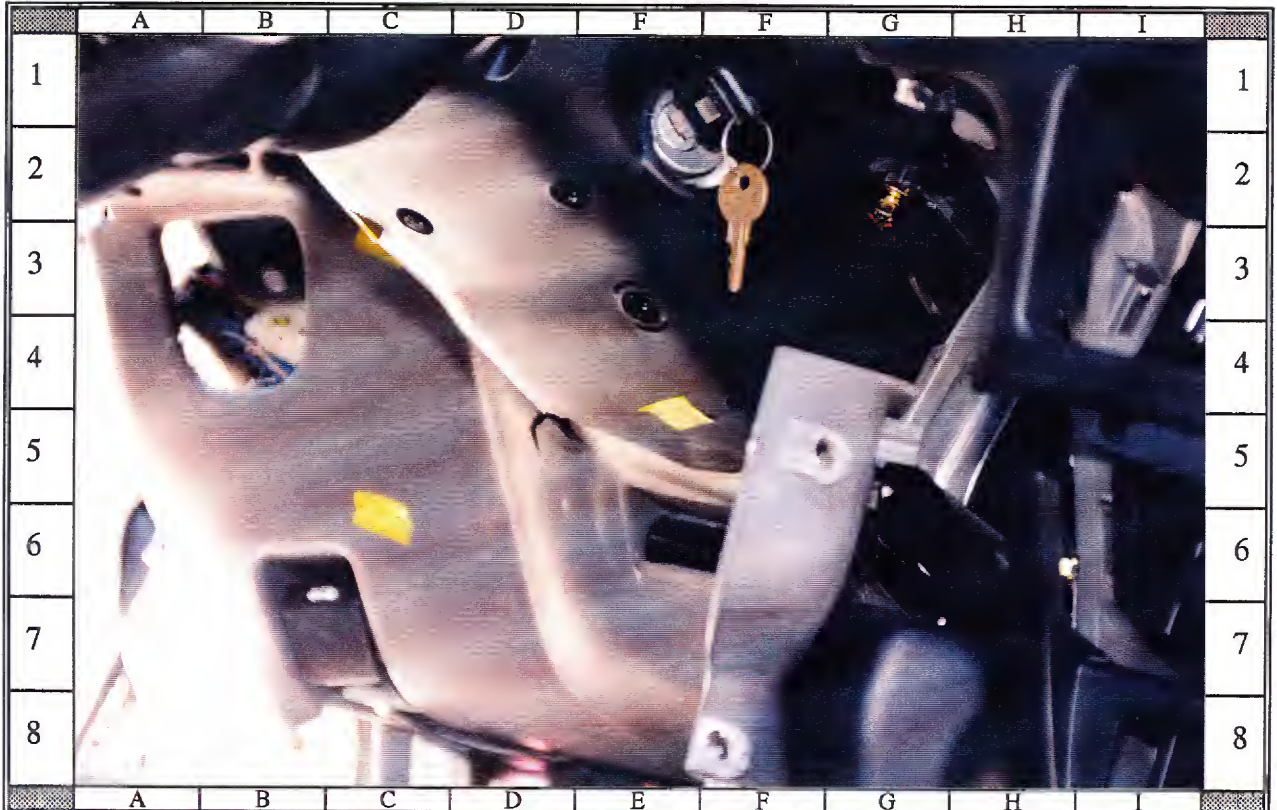
54: Close-up of Case Vehicle's left lower dash and bottom of steering column showing dash intrusion and probable occupant contacts

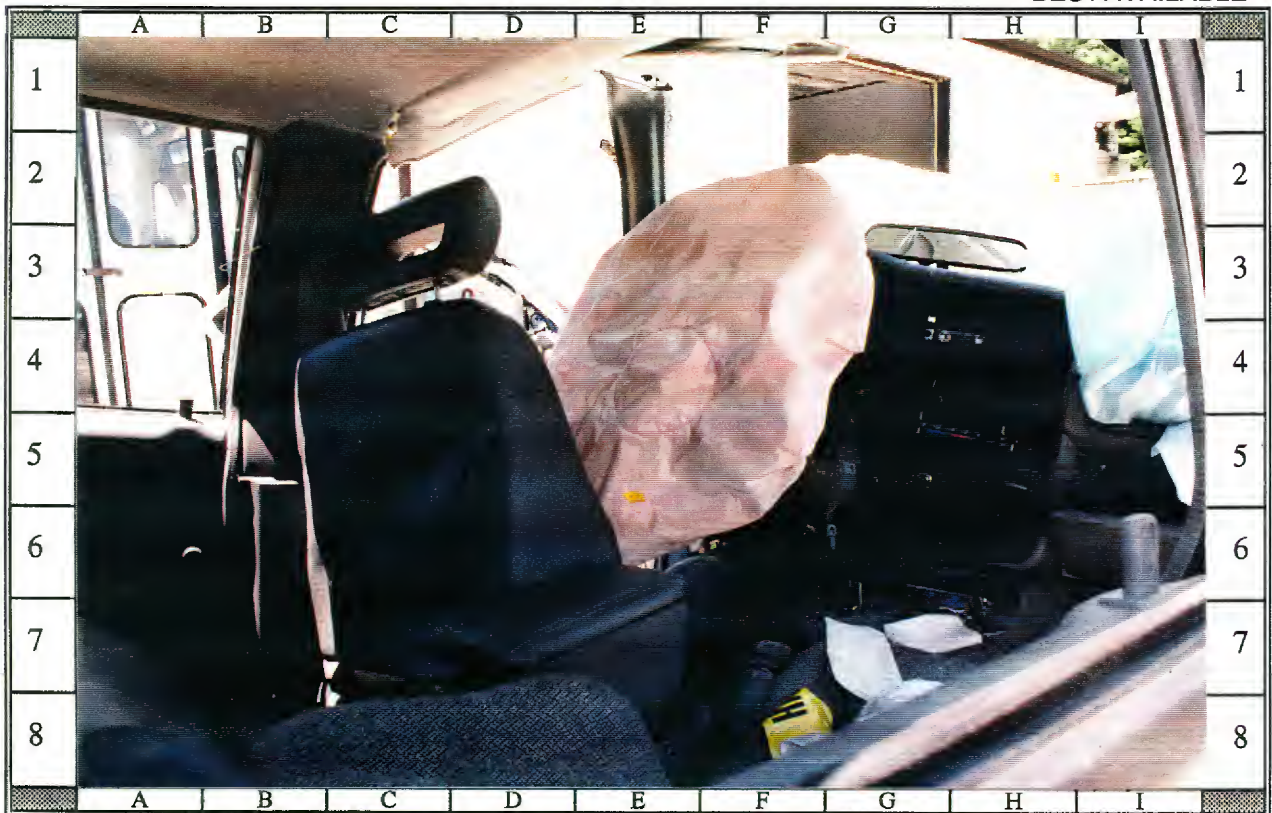
55: Case Vehicle's driver seating area viewed from the right rear; NOTE: front out-board 3-point safety belts, adjustable head restraints, and leftward tilted seatback

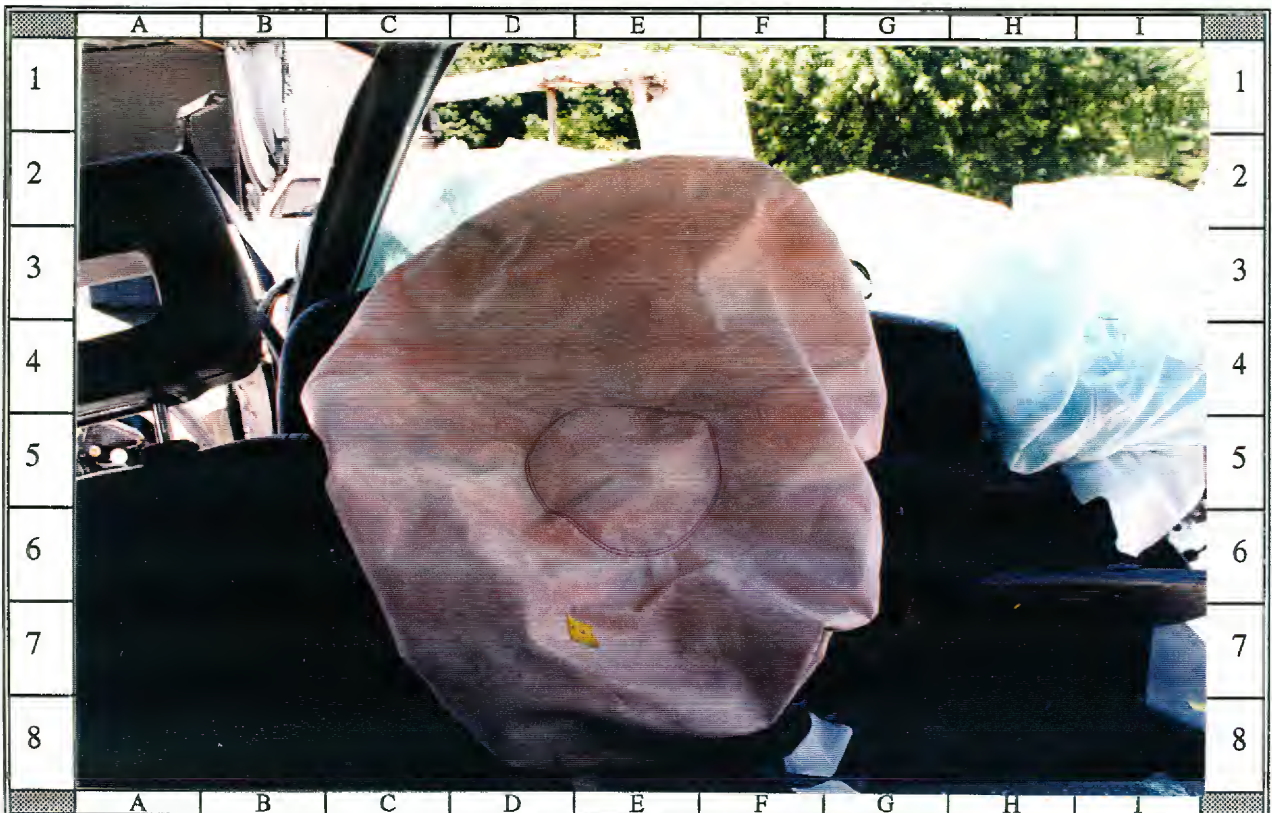
56: Case Vehicle's deployed driver air bag showing possible occupant contact point in lower center of air bag; NOTE: leftward tilting driver's seat

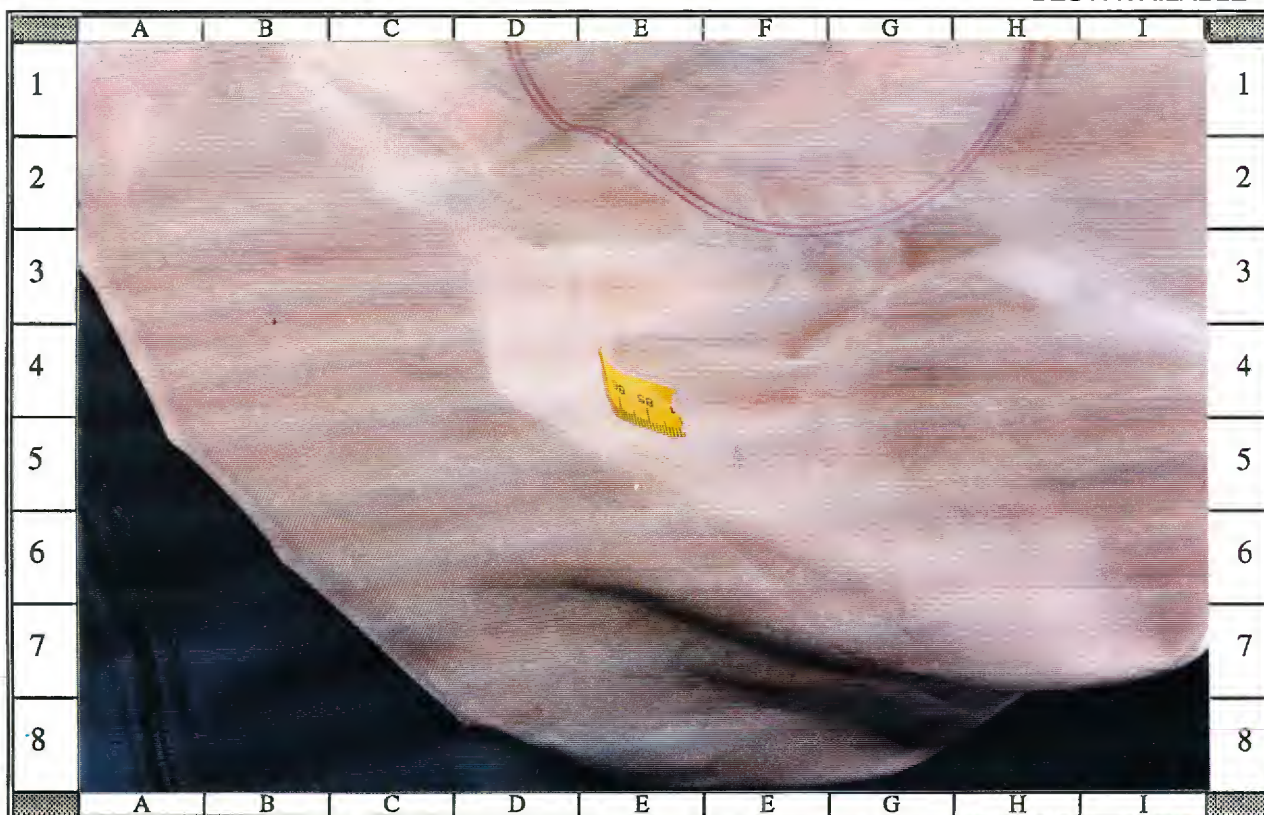
57: Close-up of Case Vehicle's deployed driver air bag showing a possible occupant contact point (i.e., unknown substance) in lower center of air bag

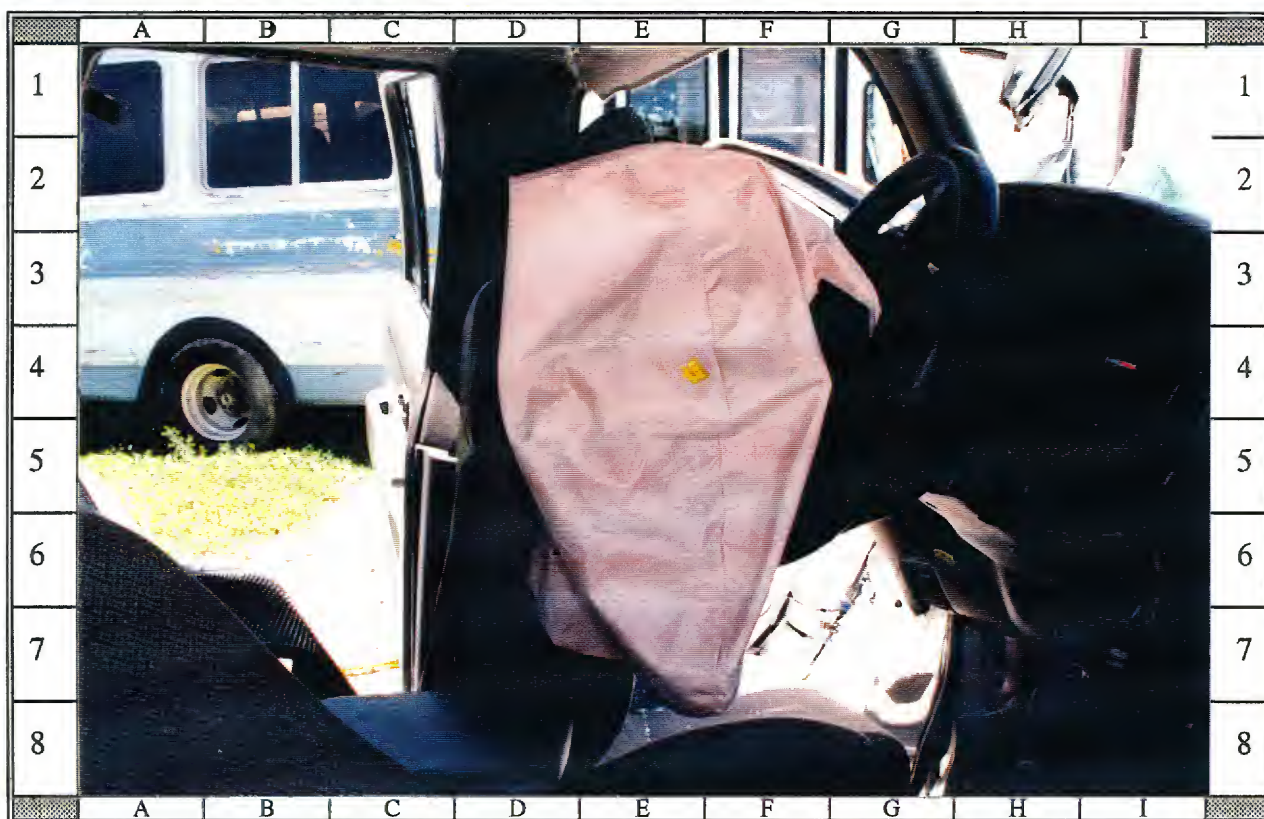
58: Case Vehicle's driver seating area viewed from right showing deployed driver side air bag; NOTE: unknown substance on air bag near right seam

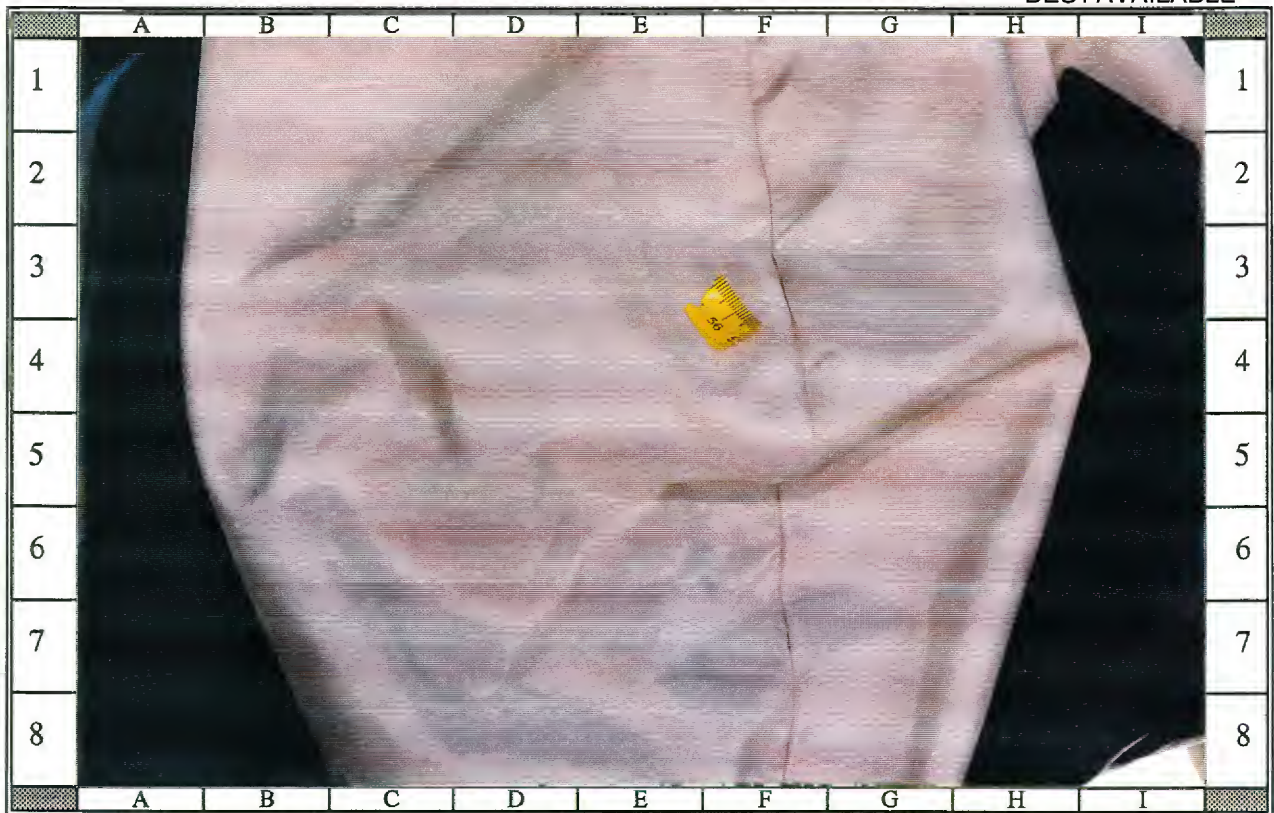
59: Close-up of Case Vehicle's deployed driver side air bag showing unknown substance near right seam

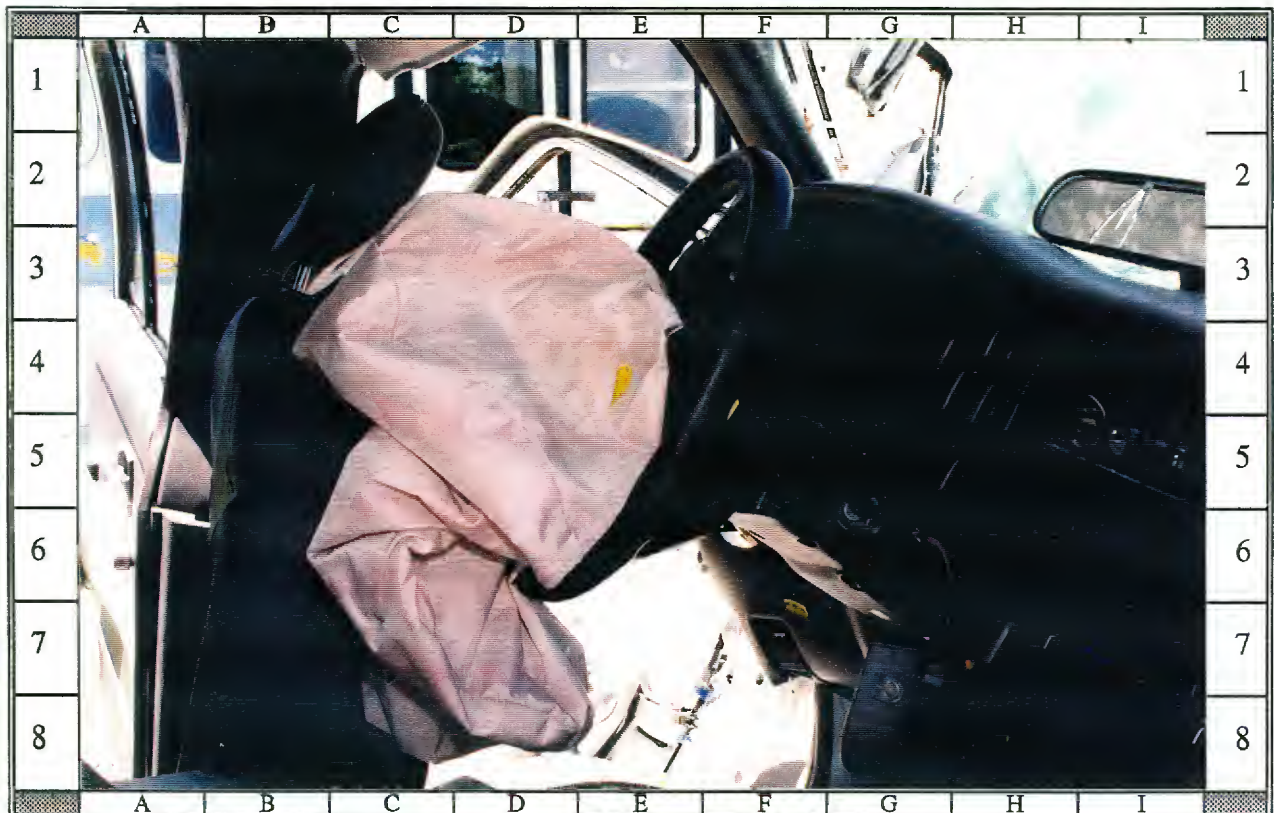
60: Case Vehicle's driver seating area viewed from right showing deployed driver side air bag; NOTE: unknown substance on right backside of air bag

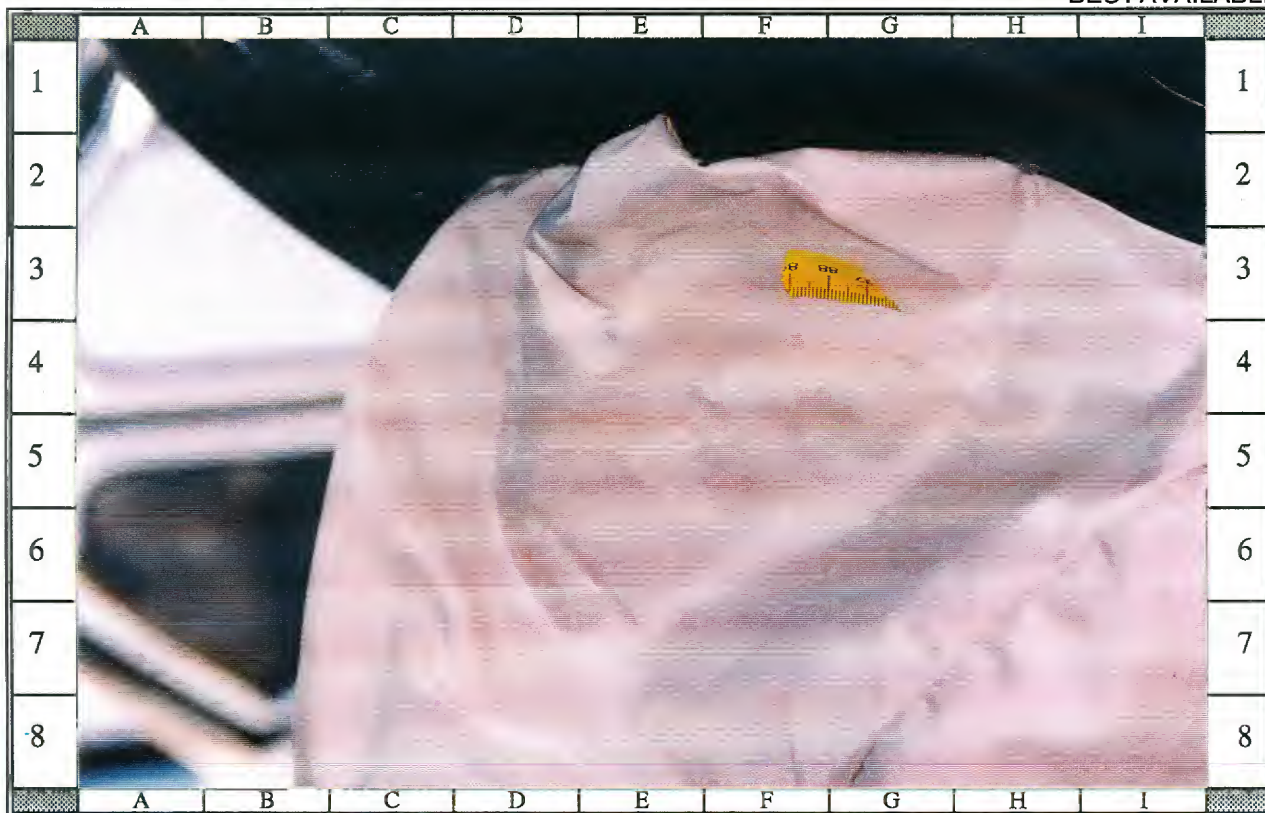
61: Close-up of Case Vehicle's deployed driver air bag showing an unknown substance on lower right backside of deployed air bag

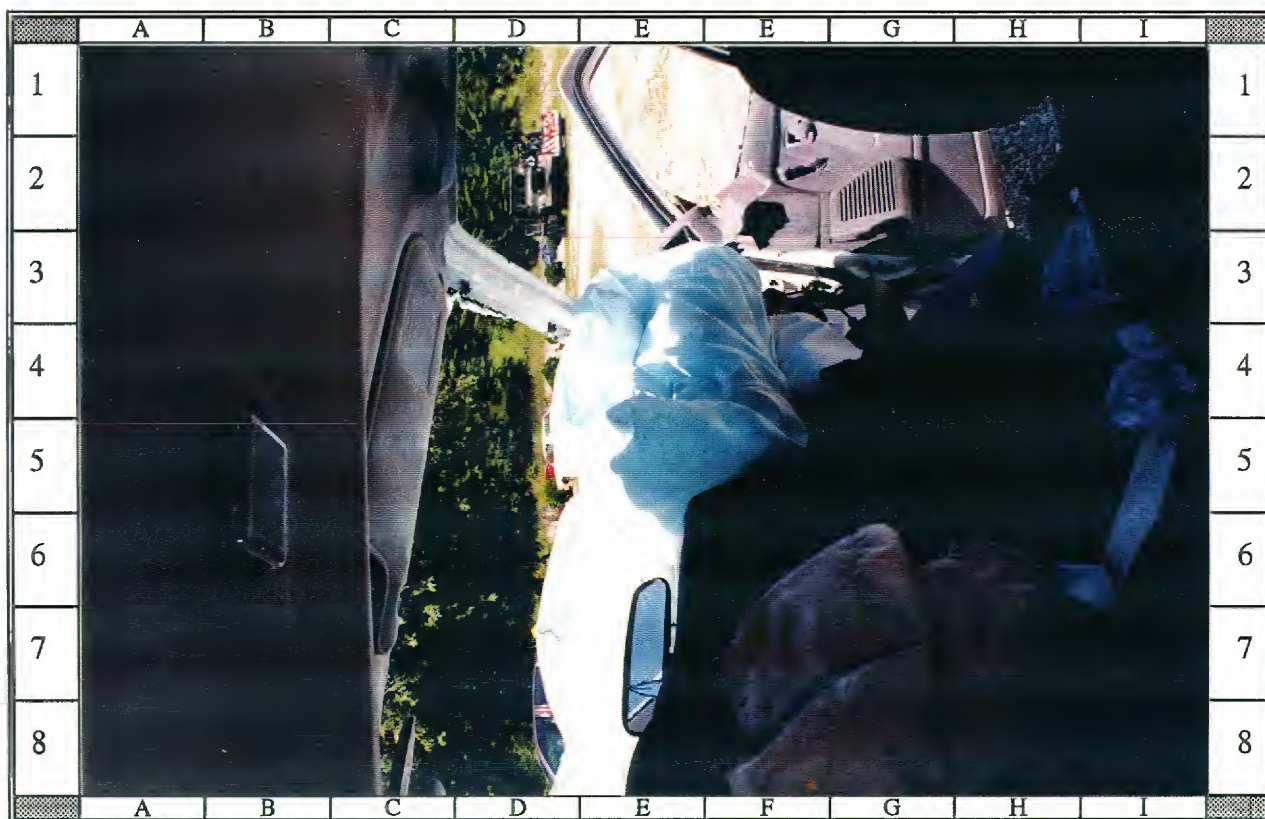
62: Case Vehicle's right front seating area viewed from left rear showing deployed air bags; NOTE: no contact evidence to right header, sunvisor, or side rail areas

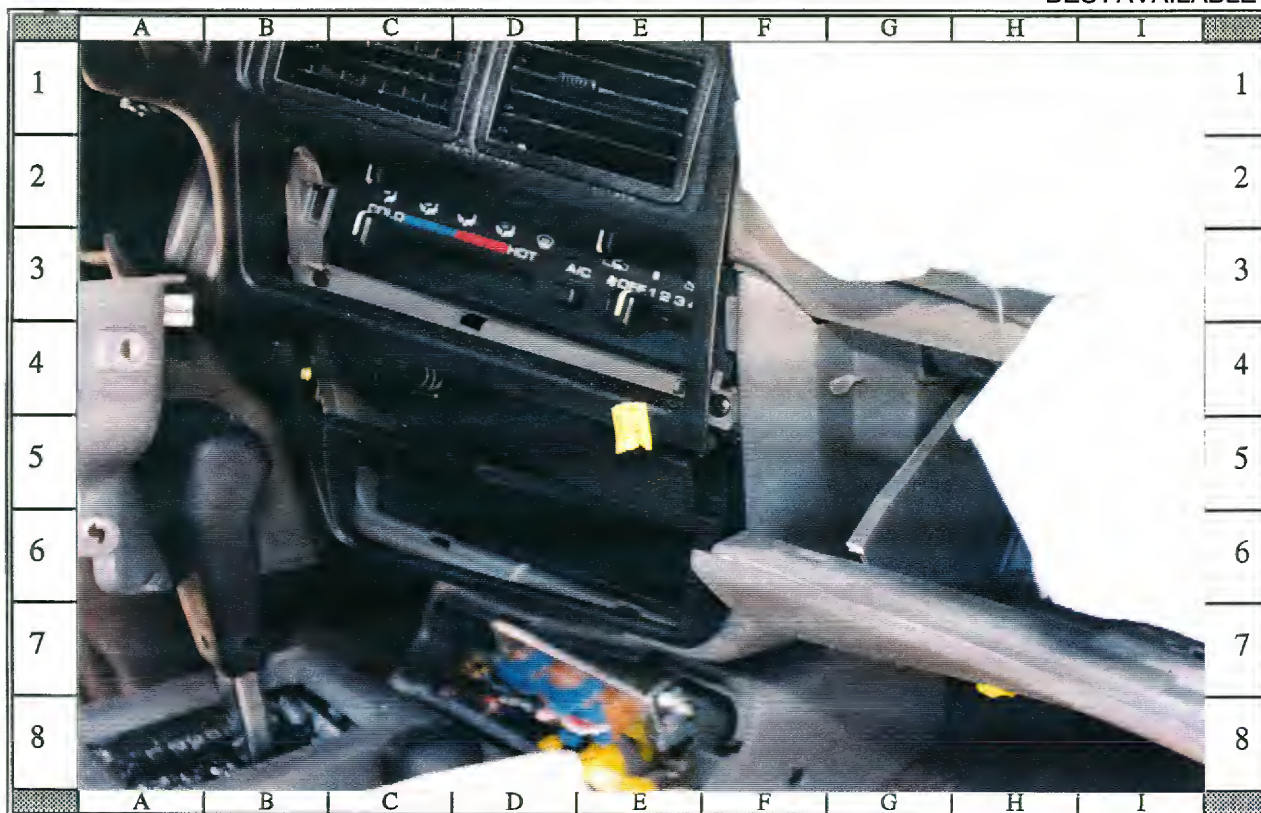
63: Close-up of Case Vehicle's center dash area showing displaced plastic covering, broken radio face, possible center contact, and deployed right front air bag

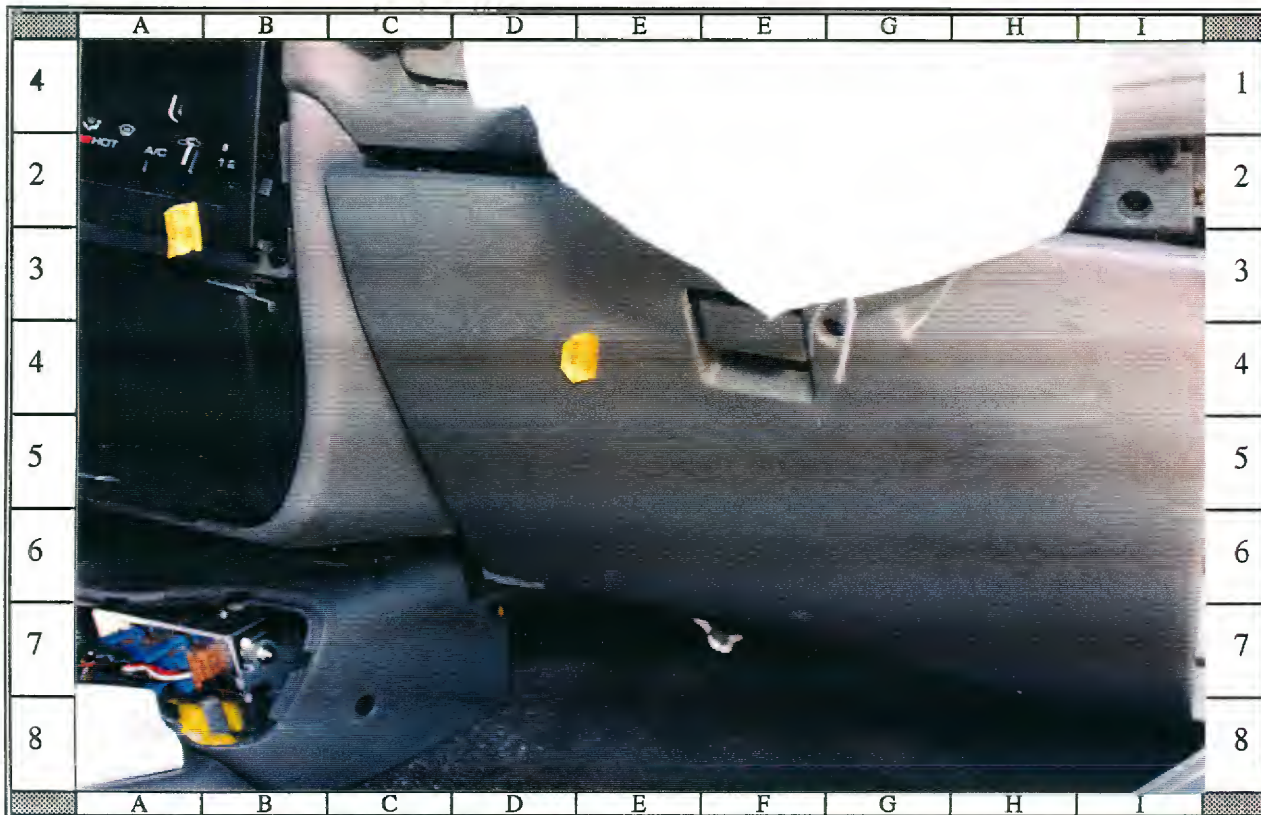
64: Close-up of Case Vehicle's glove compartment door showing possible contact point and deployed right front passenger air bag

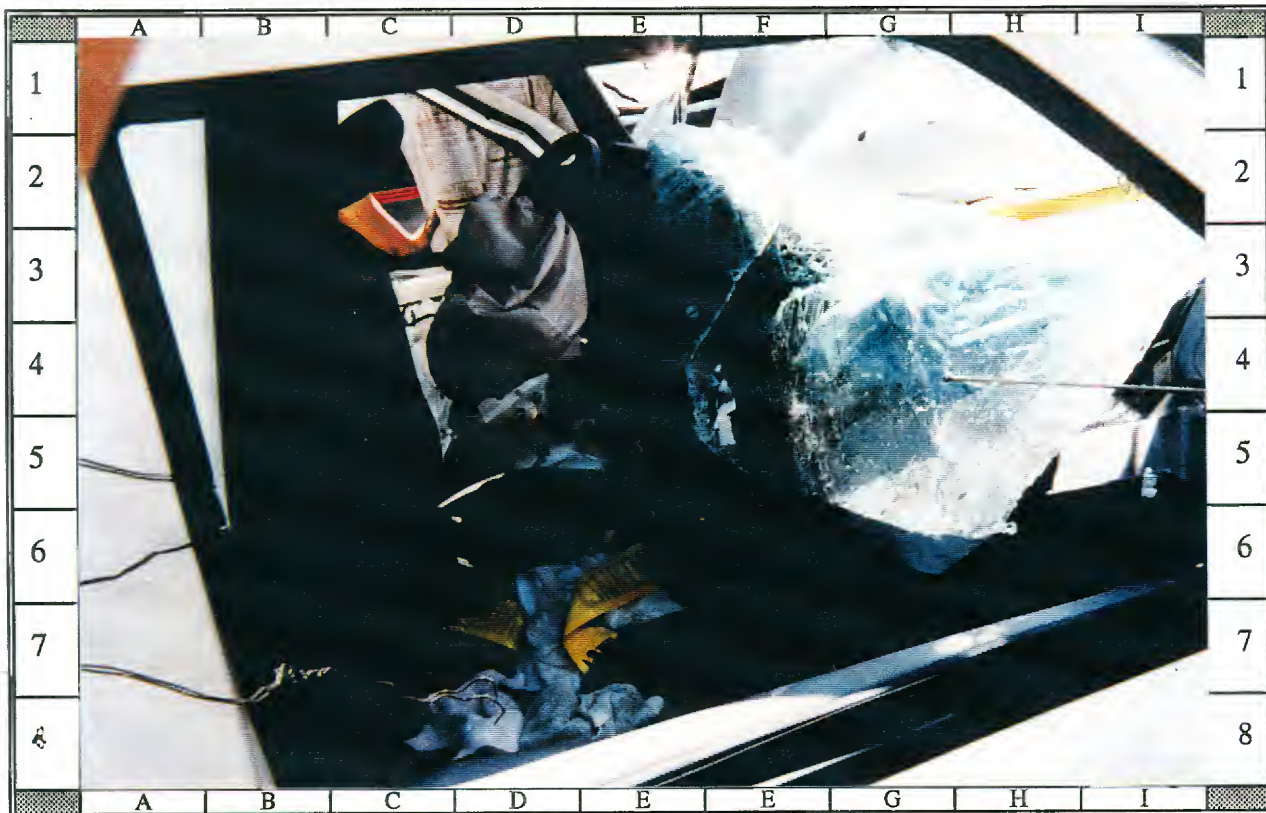
65: Case Vehicle's front seating area viewed through disintegrated right front glazing;
NOTE: windshield collapsed over passenger's air bag after extrication

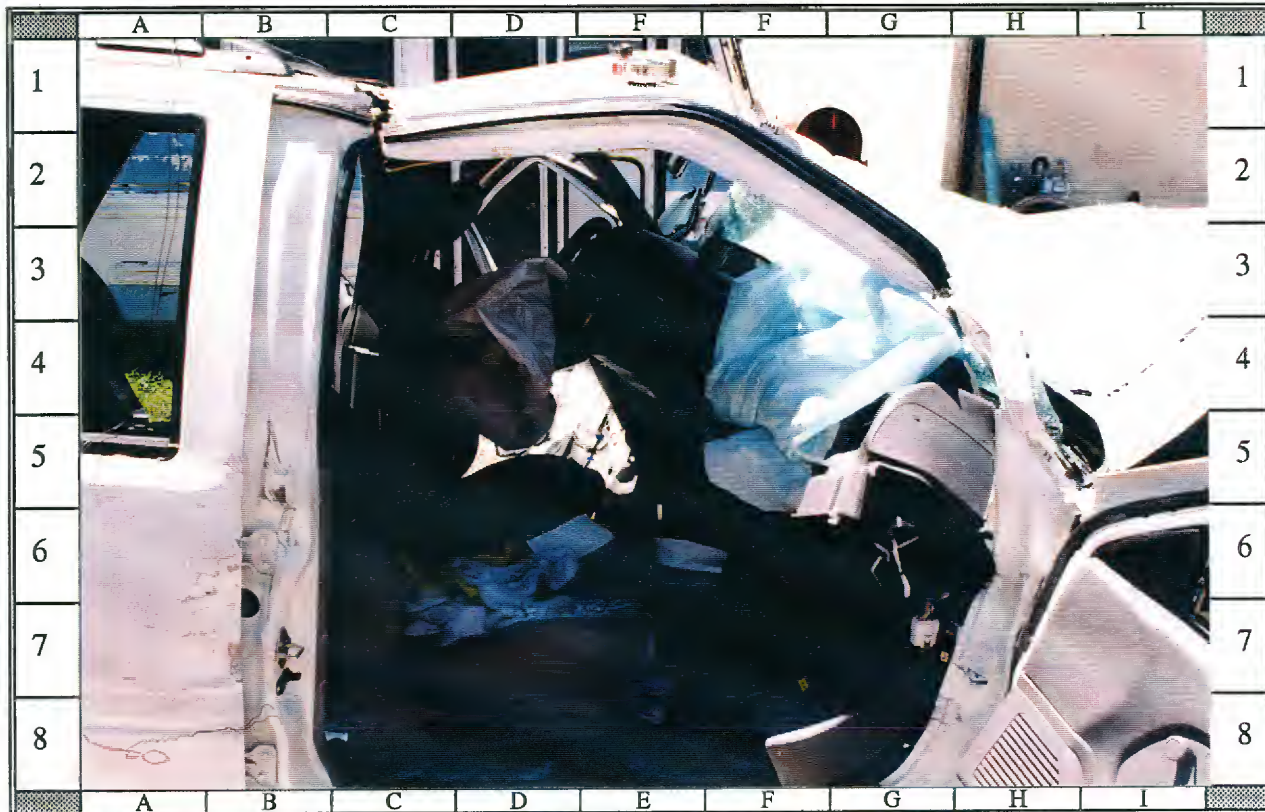
66: Case Vehicle's front seating area viewed through right front door showing extensive intrusion into driver's area and damage to right front dash and kick panel

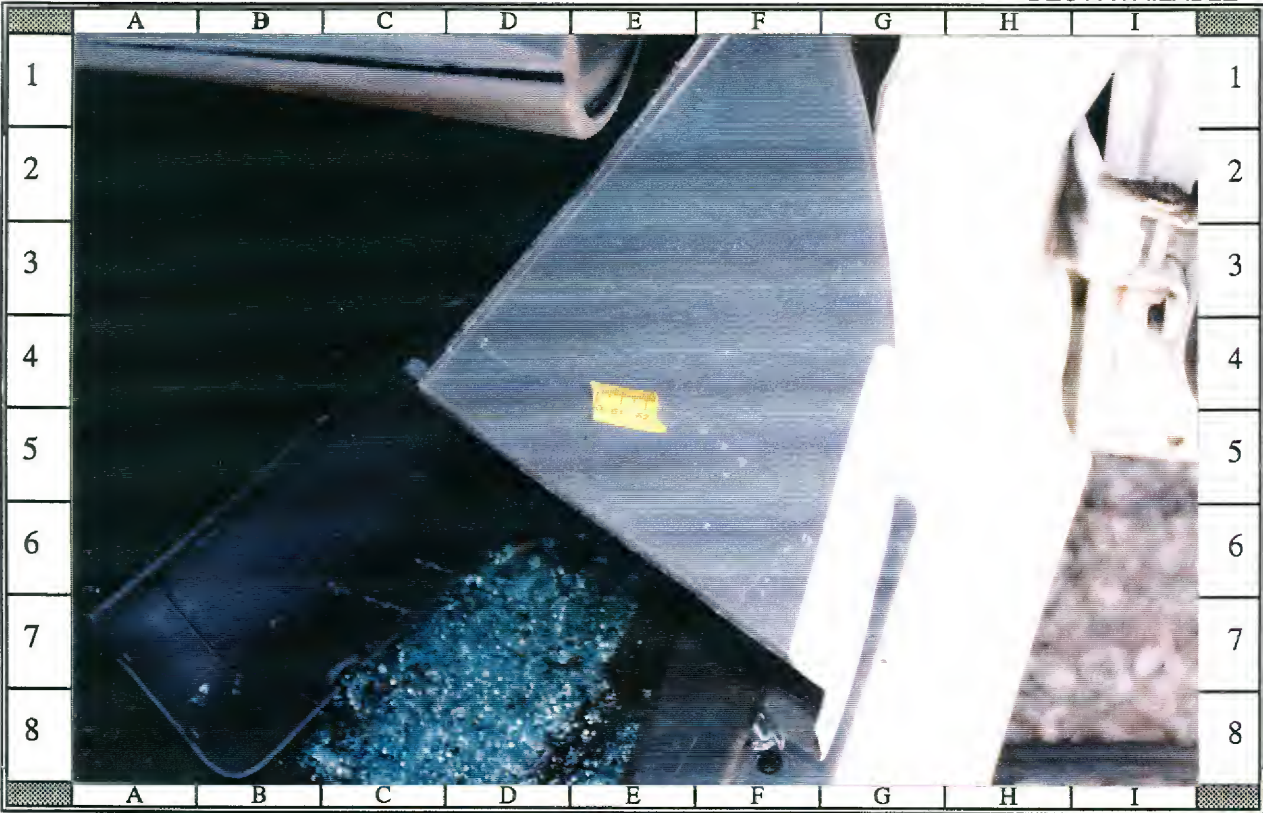
67: Close-up of Case Vehicle's right kick panel showing possible right front passenger contact
